Resource Action: EWG-16B Task Force Recommendation Category: 2

### Proposed Restoration/Improvement of Rearing Habitat for Juvenile Salmonid Fish Species

Date of Field Evaluation: June 11, 2003

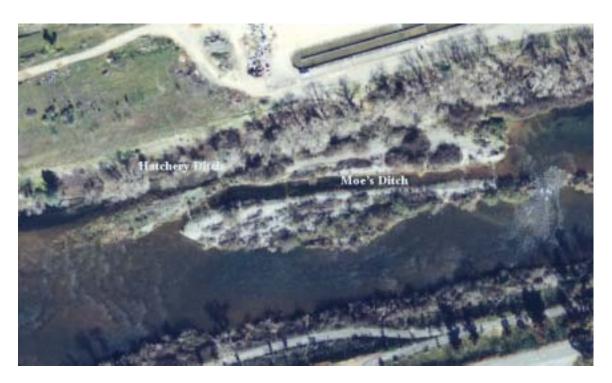
Figure 1. Hatchery Ditch and Moe's Ditch

Hatchery Ditch is a narrow, shallow, heavily shaded channel that runs along the base of the levee separating the FRH from the LFC (Figures 1 and 2). Well-developed riparian vegetation, including a number of large cottonwood trees, borders the ditch, affording it excellent cover. Flow velocity in much of the ditch was moderately high. Most of the channel has clean gravel substrate and the ditch is heavily used for spawning by steelhead (Jason Kindopp, DWR, personal communication). Inspection of the substrate during the field visit revealed many benthic macroinvertebrates. A long gravel bar lies between Hatchery Ditch and the main channel of the river. Moe's Ditch sits on this bar.

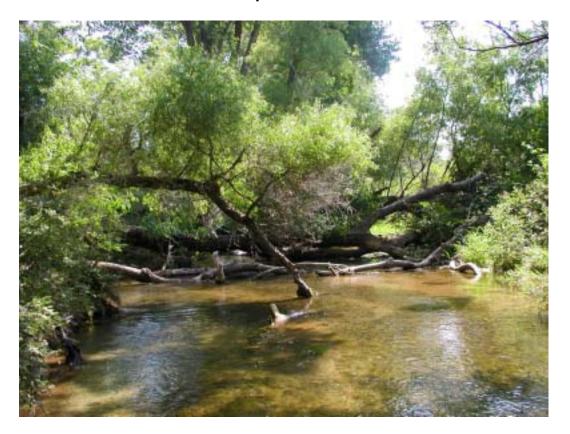
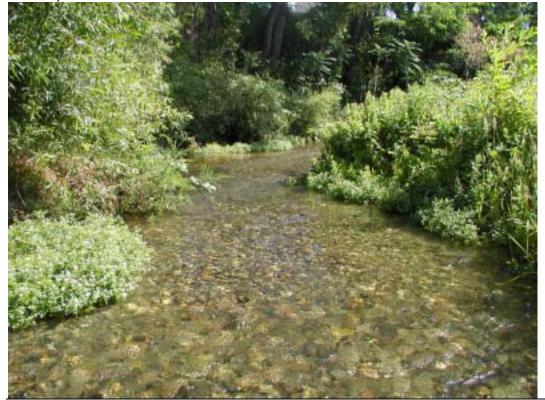
Figure 2. Hatchery Ditch: Abundant Instream Cover and Overhead Cover (top and bottom)

is heavily shaded and is well provided with instream and overhead cover (Figure 1). The channel is generally less than half a meter deep and less than three meters wide, so rearing juveniles are never far from the stream bank. However, during the field visit, flow velocities in some sections of the channel appeared to be high for small young-of-the year salmonids. These sections were relatively straight with uniform substrates and the flows were uniform and swift, providing few flow velocity refuges for small fish (Figure 4). Introducing instream structures in these sections would produce flow breaks that would likely improve the habitat.

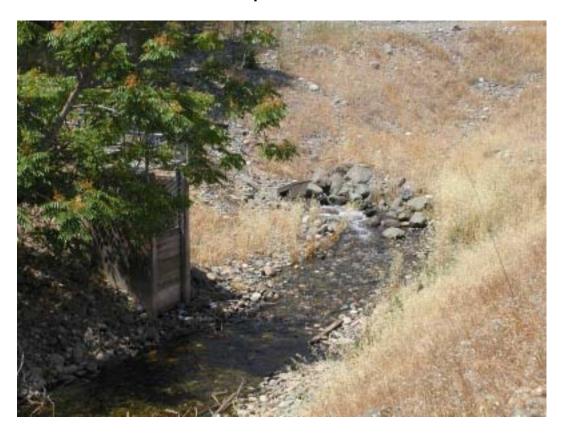
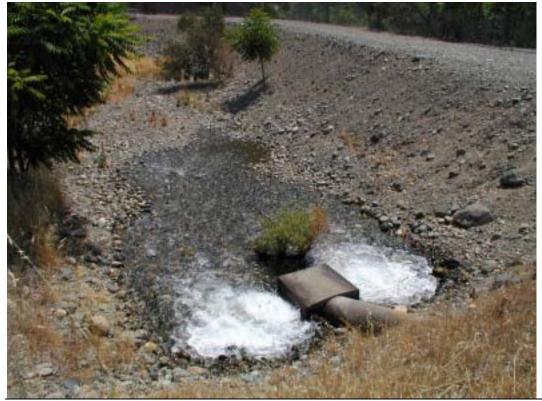
Figure 3. Feather River Hatchery Settling Ponds (top and bottom)

As previously indicated, seepage from the Feather River Hatchery (FRH) settling pond is the sole source of flow to Hatchery Ditch. Prior to the 1997 flood, Hatchery Ditch apparently had less flow and the flow percolated into the gravel, so the ditch was not connected to the river (Koll Buer, DWR, personal communication). It appears that the flood opened the channel and may have affected the levee, increasing the rate of seepage from the settling pond into the ditch (Jason Kindopp, DWR, personal communication). Currently, discharge in Hatchery Ditch is directly related to water use in the hatchery. During the field visit to the site, the settling pond retained little of the water discharged into it and the water appeared to seep rapidly through the levee into Hatchery Ditch (Figure 3). Several large, rapidly flowing seeps were found at the base of the levee near the upstream end of the ditch (Figure 4). The elevation of the channel in this area was several feet higher than that of the river. Because Hatchery Ditch does not get its flow from the river channel and because its upstream end has a higher elevation than that of the river channel, it currently functions more like a tributary than a side channel.

The most critical habitat improvement need for Hatchery Ditch is to provide a source of water other than the current FRH source. The current situation is unsustainable because of potential water quality issues, over-attraction of steelhead spawners, levee damage, and pressing FRH flowline maintenance needs. Because the upstream end of the Hatchery Ditch channel sits at a higher elevation than that of the adjacent river channel, flow cannot be provided to the ditch by breaching the bar that separates the two channels. Two alternatives have been proposed for diverting river water into the channel. One solution would be to pump water from the river into the upstream end of the channel. The channel currently receives up to 25 cfs, which would require a large pump, but less flow may suffice (Jason Kindopp, DWR, personal communication). In any case, the pump would be too large to be portable and would therefore have to be installed well above flood stage. Other potential solutions would be to construct a flowline to divert water from an upstream location in the main river channel or from the Fish Barrier Dam pool. All of these alternatives would be costly.

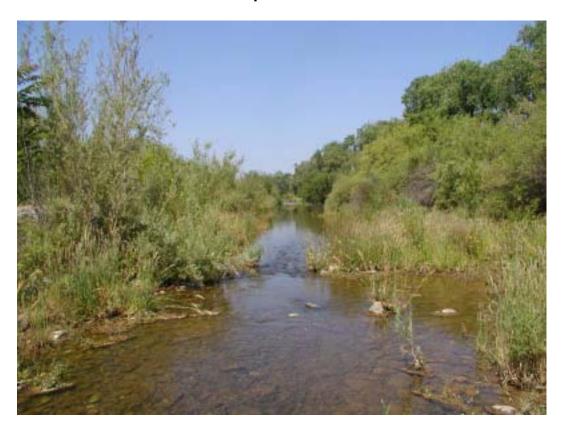
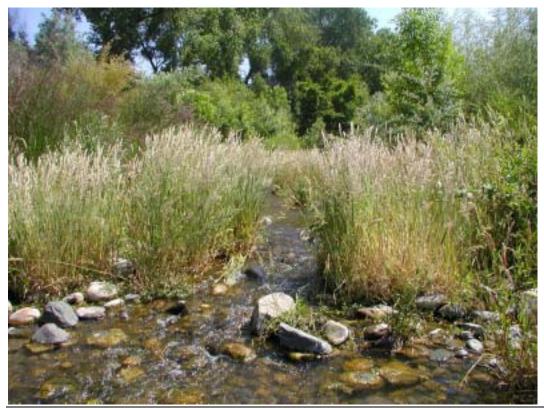
Figure 5. Moe's Ditch: Upstream End (top), Downstream End (bottom)

Moe's Ditch is a broad, straight, exposed man-made channel adjacent to Hatchery Ditch (Figures 1 and 5). The channel was initially constructed in the 1970s to enhance salmonid spawning. The ditch has been regraded many times and complete reconstruction has been required after several flood events. The ditch was adversely affected by the 1997 flood and currently provides little spawning or rearing habitat. Young willows border much of the ditch, but they provide little cover.

Moe's Ditch begins at the upstream end of Auditorium Riffle and flows downstream over the gravel bar for about 1/7th of a mile, where it discharges back to the river. The upstream end is clogged with gravel that restricts flow in the channel. Apparently, such blockage has been a frequent problem for the channel (Koll Buer, DWR, personal communication). Because of the low flow, shallow depths and exposure, substrate at the upper end of Moe's Ditch is blanketed with algae. Beavers have constructed a dam near the lower end of the ditch; so much of the channel has been converted into a pool.

Because of low flow, vegetation is heavily encroaching into the channel at the downstream mouth of the ditch (Figure 5).

Habitat conditions in Moe's Ditch contrast sharply with those in Hatchery Ditch. Moe's Ditch is quite broad and has little flow. A beaver dam backs up the flow in much of the channel, creating a large area of pool habitat. The most immediate need for restoring habitat in Moe's Ditch is to remove the gravels that restrict flow from the river channel. If the channel was opened the flow entering the ditch might wash out the beaver dam. Otherwise the dam would have to be removed mechanically.

The broad channel of Moe's Ditch is suitable for spawning habitat, which was the original objective of the habitat design, but it is too exposed to provide good rearing habitat. A new, narrower channel in the same area would provide better rearing habitat and would be easier to maintain with adequate flows. In addition, a narrower channel could more easily be routed through existing riparian vegetation or be enhanced with vegetation improvements to provide instream and overhead cover. Finally, a narrow channel could be provided with meanders to create more habitat complexity, including variable flow velocities. Hydraulic modeling could be used to help design a channel producing flow velocities and depths suitable for rearing salmonids.
